# Belvidere Theatre

129 Nevada Street  
Central City, Colorado 80427

Historic Structure Assessment and  
Preservation Plan  
SHF Grant No. 2016-HA-005  
Deliverable #5 Final HSA  
July 2016

**HISTORIC STRUCTURE ASSESSMENT  
AND  
PRESERVATION PLAN**

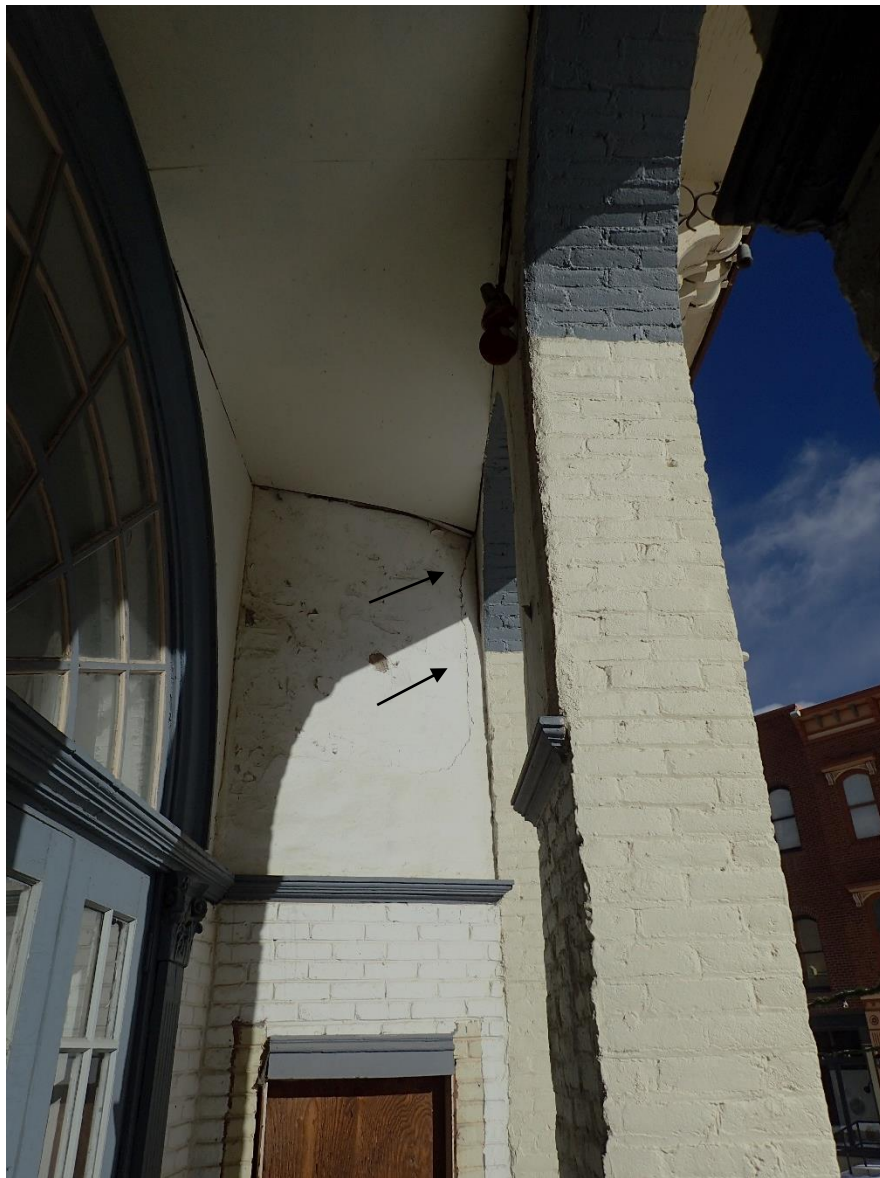
Figure 11: Vertical cracking between façade and perpendicular wall
